COMMISSION FOR HISTORICAL & ARCHITECTURAL PRESERVATION

STAFF REPORT

REQUEST: Demolition Hearing One – Determination of Architectural Significance – Demolish One-Story Garage

ADDRESS: 814 Park Avenue (Mount Vernon Historic District)

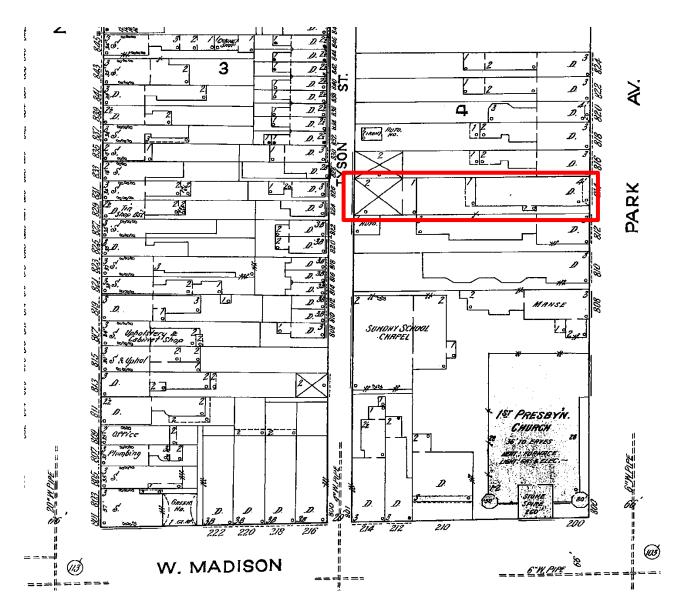
The garage at 814 Park Avenue is not original to the construction of the main building at the site and was likely constructed following the demolition of the historic carriage house in the late 1940s, outside of the period of significance. This garage is shown in the 1951 Sanborn Map where it is listed as housing 14 cars. The previous Sanborn Map from 1936 shows a two-story carriage house at the location.

Map 2: 1936 Sanborn Map; 814 Park Avenue, including a two-story carriage house, is outlined in red.

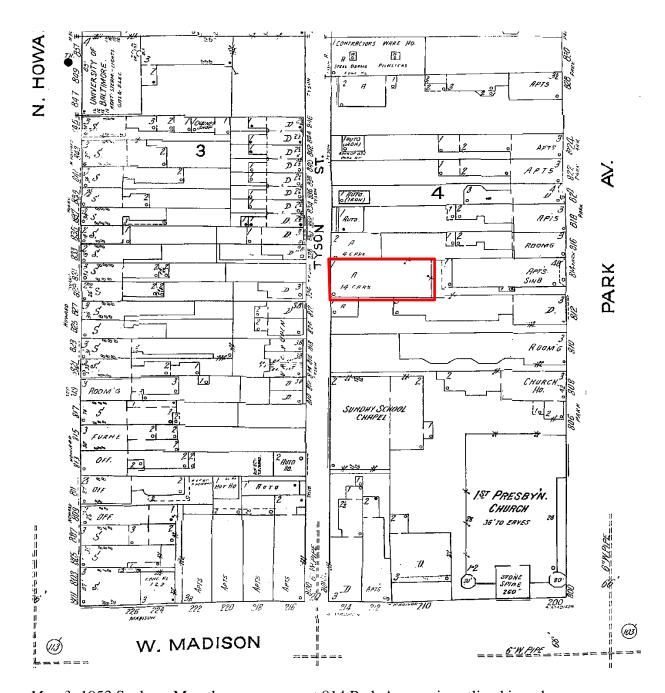
Map 3: 1953 Sanborn Map; the rear garage at 814 Park Avenue is outlined in red.

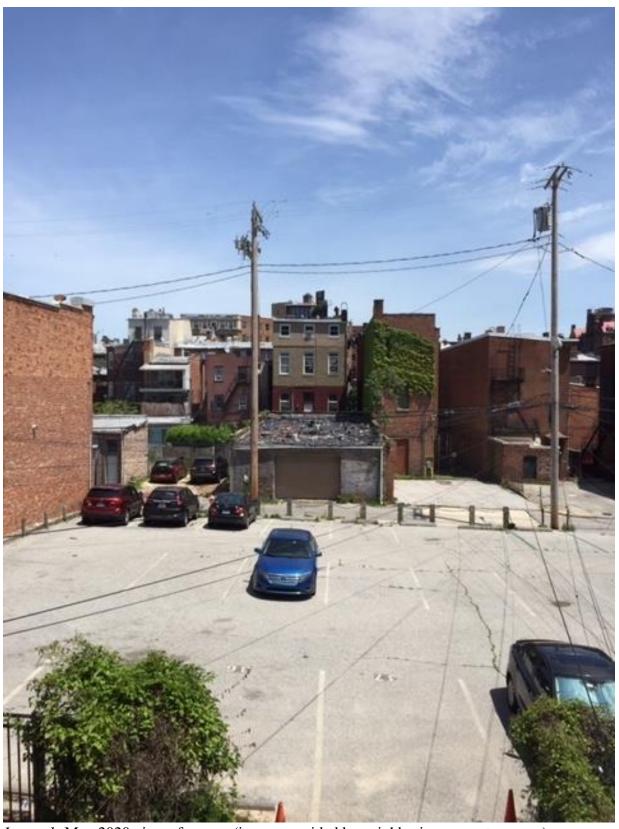
Image 1: May 2020 view of garage (image provided by neighboring property owner)

The garage at 814 Park Avenue is in poor condition. A lack of maintenance to the building has resulted in a building with missing mortar, loose and missing bricks, mature vegetation growing from the walls and roof, and a deteriorating roof (*Image 1*). The brick has been painted, and this paint is loose and missing from large portions of the brick. A portion of an adjacent garage wall conceals some of the south elevation; the space between these two walls is the location of the largest plant growth (*Image 2*).

Staff finds that the garage at the rear of 814 Park Avenue lacks architectural significance and was likely constructed after the period of significance. Additionally, the building is severely deteriorated with extensive damage to the roof and walls from vegetation and lack of maintenance.

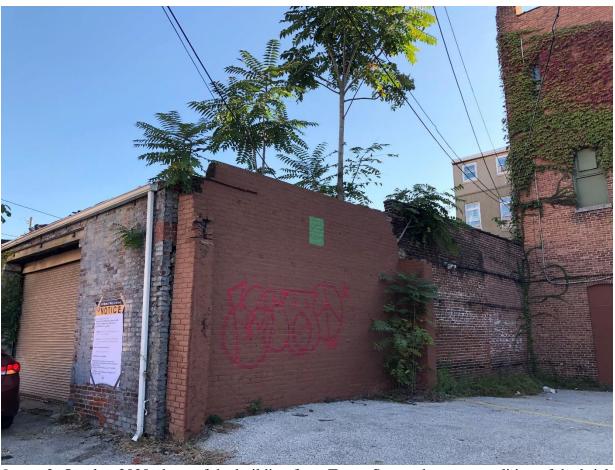
Image 2: October 2020 photo of the building from Tyson Street; the poor condition of the brick is visible, as is the vegetation growing out of the building, including the fast-growing invasive Tree of Heaven, which has an aggressive and damaging root system.
